April 9, 2021

The Lakes Homeowners Association  
529 Saluda River Road  
Myrtle Beach, South Carolina 29588

Reference: **Report of Pavement Exploration Services**  
**Pavement Inventory and Rehabilitation Plan – The Lakes**  
Surfside Beach, South Carolina  
S&ME Project No. 3563-20-064

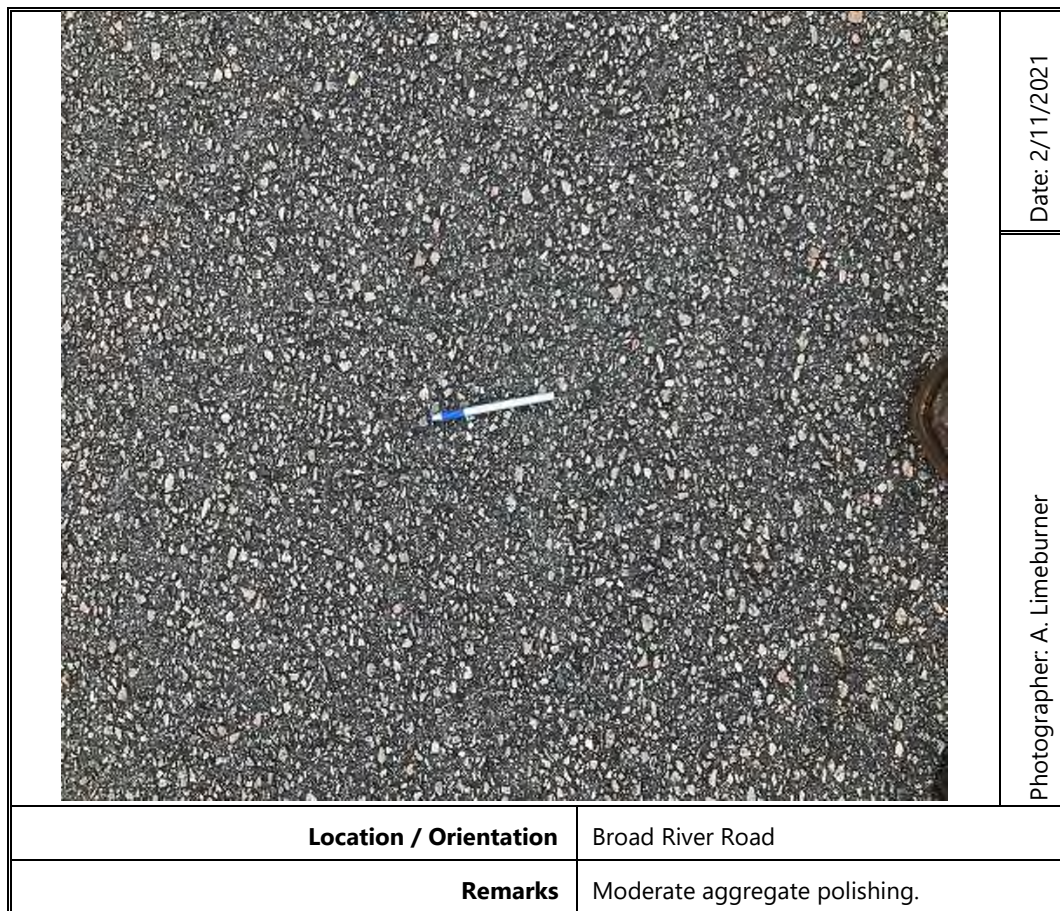
**Photo 1: Aggregate Polishing**

Polished aggregates were observed on most of the asphalt pavement surfaces observed. Polishing occurs when the bitumen (the asphaltic material) on top of the aggregates in the asphalt mixture has worn away. Over time, most aggregates are susceptible to wearing to a smooth finish or texture under repeated traffic. This may reduce traction and contribute to loss of ductility. It also reduces the adhesion of surface sealers that may be applied. See **Photo 1** below for an example of the distress observed.

Prior to performing the taper milling, any areas of the roadway surface that are exhibiting severe fatigue (alligator) cracking should be removed and replaced with a full-depth asphalt patch. This involves cutting and removing the asphalt from the fatigued area including a buffer that extends a nominal distance into the surrounding unstressed area. The depth of the cut may vary from 4 to 8 inches, depending upon the conditions encountered. The area is then filled with hot mix asphalt to 2 inches below final grade elevation. (Note: the last 2 inches will be part of the overlay of the entire roadway).

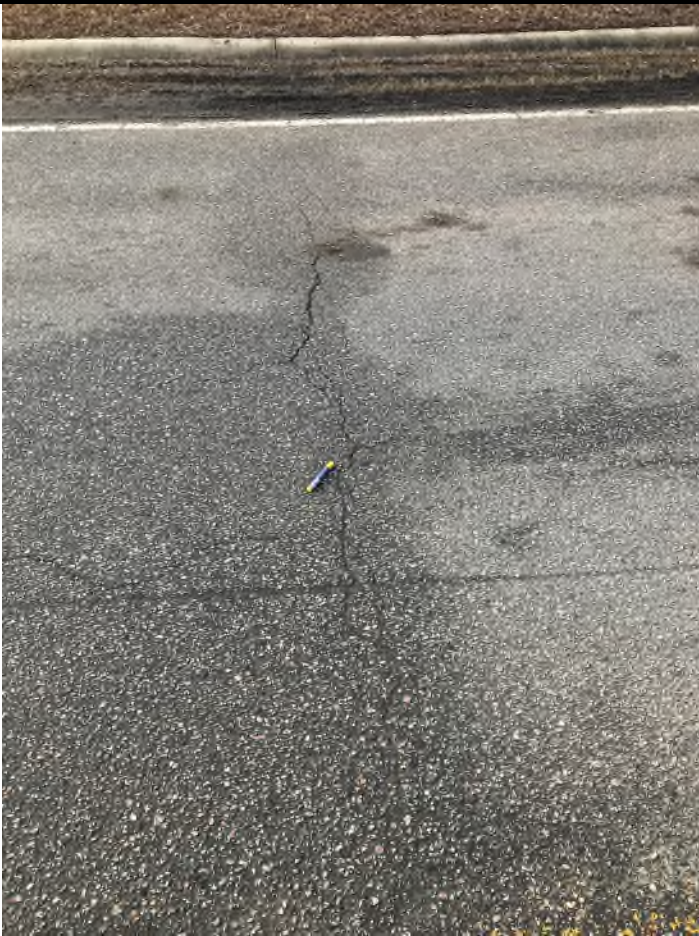
**Photo 2: Transverse Cracking**

Slight to moderate transverse cracking was observed on each of the roadways except Harbor Drive. Transverse cracks are those oriented generally perpendicular to the pavement centerline. This type of cracking may be caused by fatigue or shrinkage of the asphalt, or deformation of the base or subgrade. Transverse cracking can also be caused by shrinkage of the underlying base material which then reflects up through the overlying asphalt, which is a typical response to cement-stabilized base materials. See **Photo 2** below for an example of transverse cracking.

| <b>Remarks</b> | Moderate Transverse Cracking | |

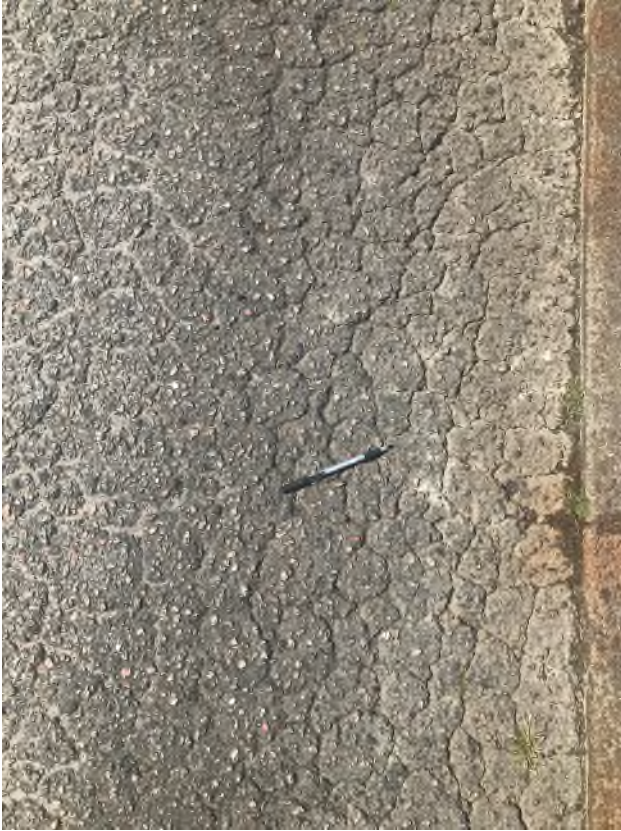
**Photo 3: “Alligator” Fatigue Cracking**

Fatigue (“alligator”) cracking was observed in some isolated locations on the asphalt roadways. Alligator cracking generally indicates areas where the base course and/or subgrade are weaker than necessary to support the applied traffic loads, and/or the asphalt is too thin for the wheel loads applied. The deflection of the pavement under traffic loading in these areas eventually causes the asphalt to break up and separate into small pieces due to excess tensile stress and strain at the bottom of the asphalt layer. Some of the roadways that we explored displayed moderate to severe alligator cracking, indicating a prolonged period of distress. See **Photo 3** below for an example of the distress observed.

| <b>Remarks</b> | Isolated but severe alligator cracking. | |

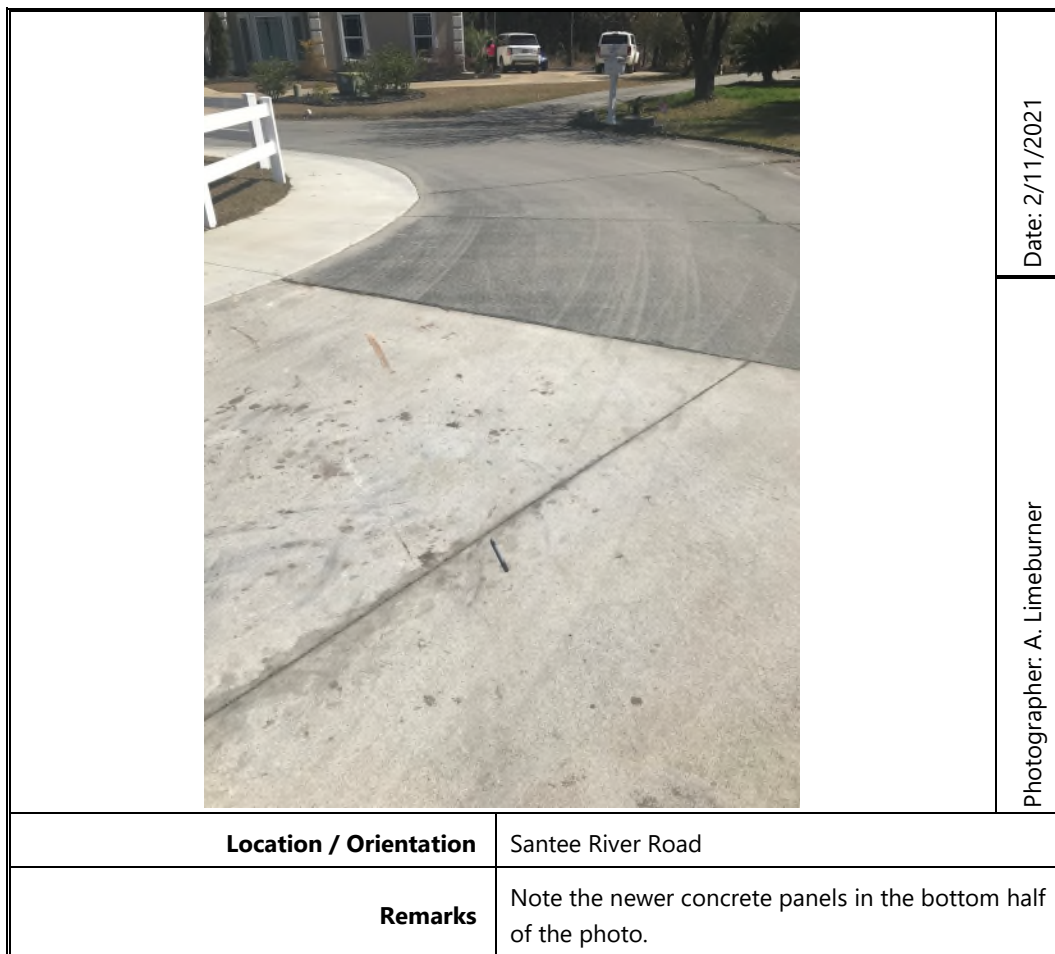
**Photo 4: Existing PCC Patch**

On some of the PCC roadways it was observed that some of the concrete panels have been replaced in the past. This indicates that the concrete panels may have failed due to age or poor subgrade conditions. See **Photo 4** below for an example of the replaced concrete panels observed.

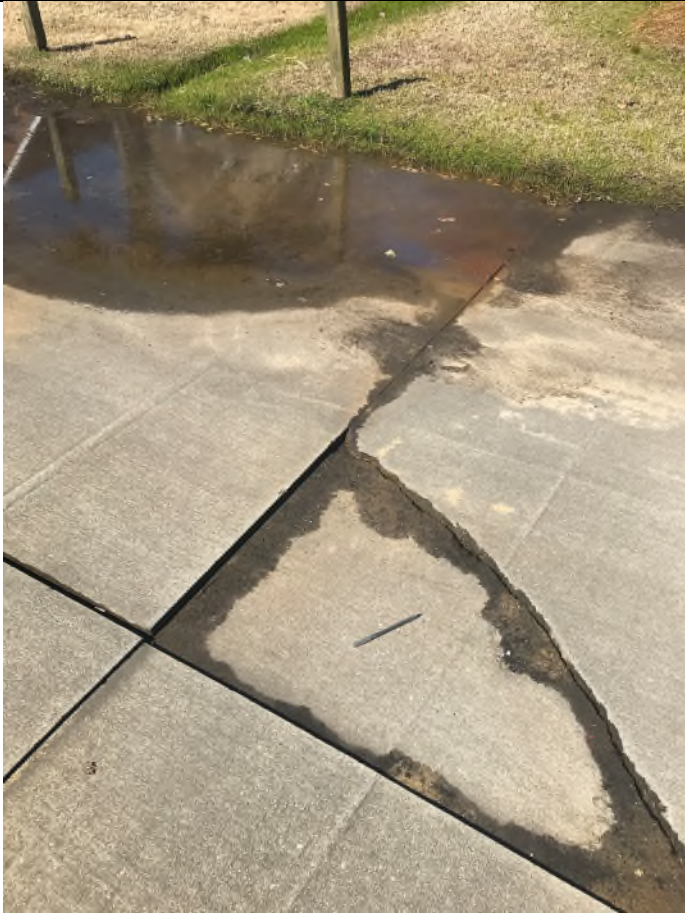
**Photo 5: Cracked and Depressed Concrete**

We also observed depressions (with or without significant associated cracking) on many of the concrete roadways in the exploration area. These depressions appeared randomly through the concrete pavement and may be a result of loose or softened subgrade or base materials underneath. The cracks and depressions may also be a result of poor subsurface drainage. **Photo 5** below shows an area of cracked and depressed concrete with standing water around it. This photo was taken after a period of relatively dry weather.

| <b>Remarks</b> | Note the standing water and the water coming through the cracked concrete. | |

Concrete panels that are exhibiting cracking and depressions should be individually removed and replaced, as follows.

1. Demolish the existing PCC pavement within the affected area including a nominal buffer around it to extend reliably into the surrounding unstressed area.

2. After removal of the distressed panel(s), undercut the existing subgrade soils to a nominal depth of 1 foot below bottom of the existing pavement elevation, and tamp the exposed soil subgrade with light, portable compaction equipment. Have the engineer observe this process to confirm suitable subgrade stability; perform any further necessary stabilization measures as directed by the engineer.

3. Install a layer of non-woven filter fabric such as TenCate Mirafi model 140N geotextile in the bottom of the excavation in general accordance with the manufacturer's recommended installation procedures.

4. Backfill the over-excavated zone to 6 inches below final grade elevation with washed, coarse, manufactured (crushed) granitic gravel size SCDOT No. 57 or No. 67.

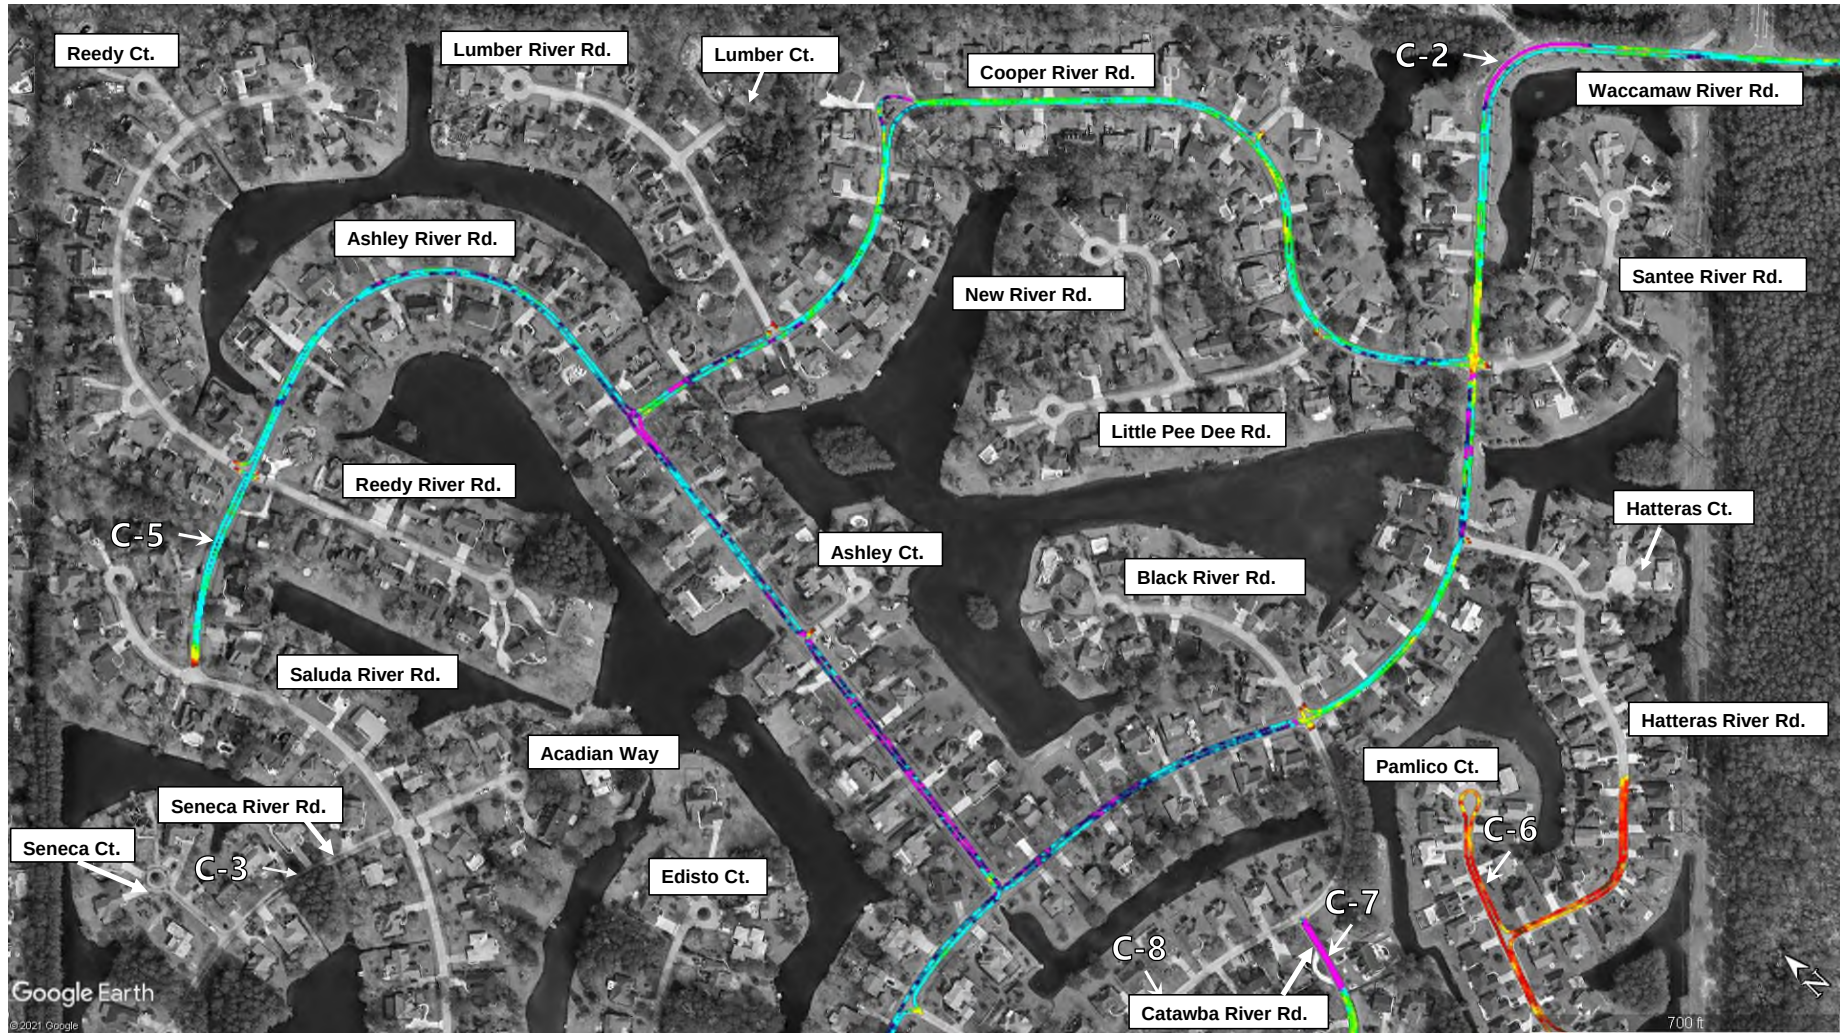
ASPHALT THICKNESS PLOT - AREA A

- A. Areas colored in **orange** and **red** on **Figures 4, 7 and 10** indicate areas where the asphalt layer appears to be less than 2 inches thick, which only occurred in a few of the explored roadways. Areas colored in **yellow** on **Figures 4, 7 and 10** indicate areas where the asphalt layer appears to be less than 2.5 inches thick, which only occurred in a few isolated spots.

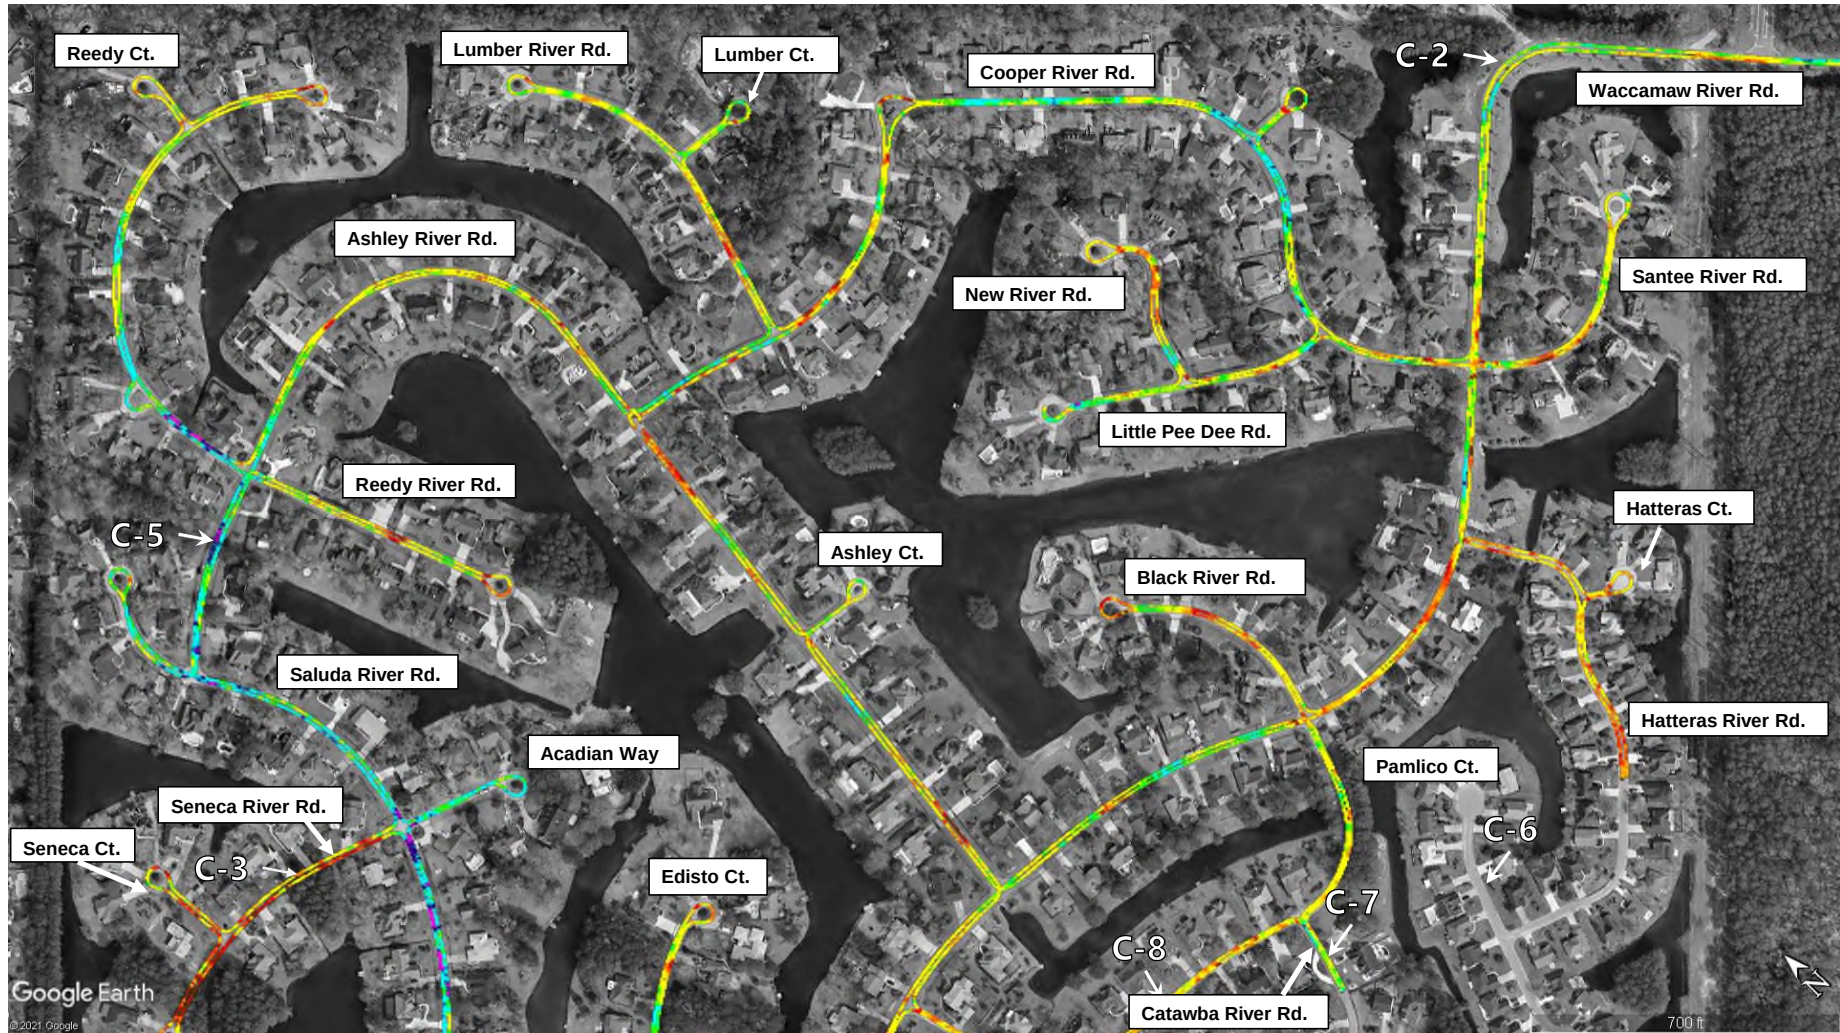
CONCRETE THICKNESS PLOT - AREA A

- B. Areas colored in **orange** and **red** on **Figures 5, 8 and 11** indicate areas where the PCC layer appears to be less than 6 inches thick, which occurred in several isolated spots. Areas colored in **yellow** on **Figures 5, 8, and 11** indicate areas where the PCC layer appears to be less than 7 inches thick, which was common throughout significant portions of the evaluated area.

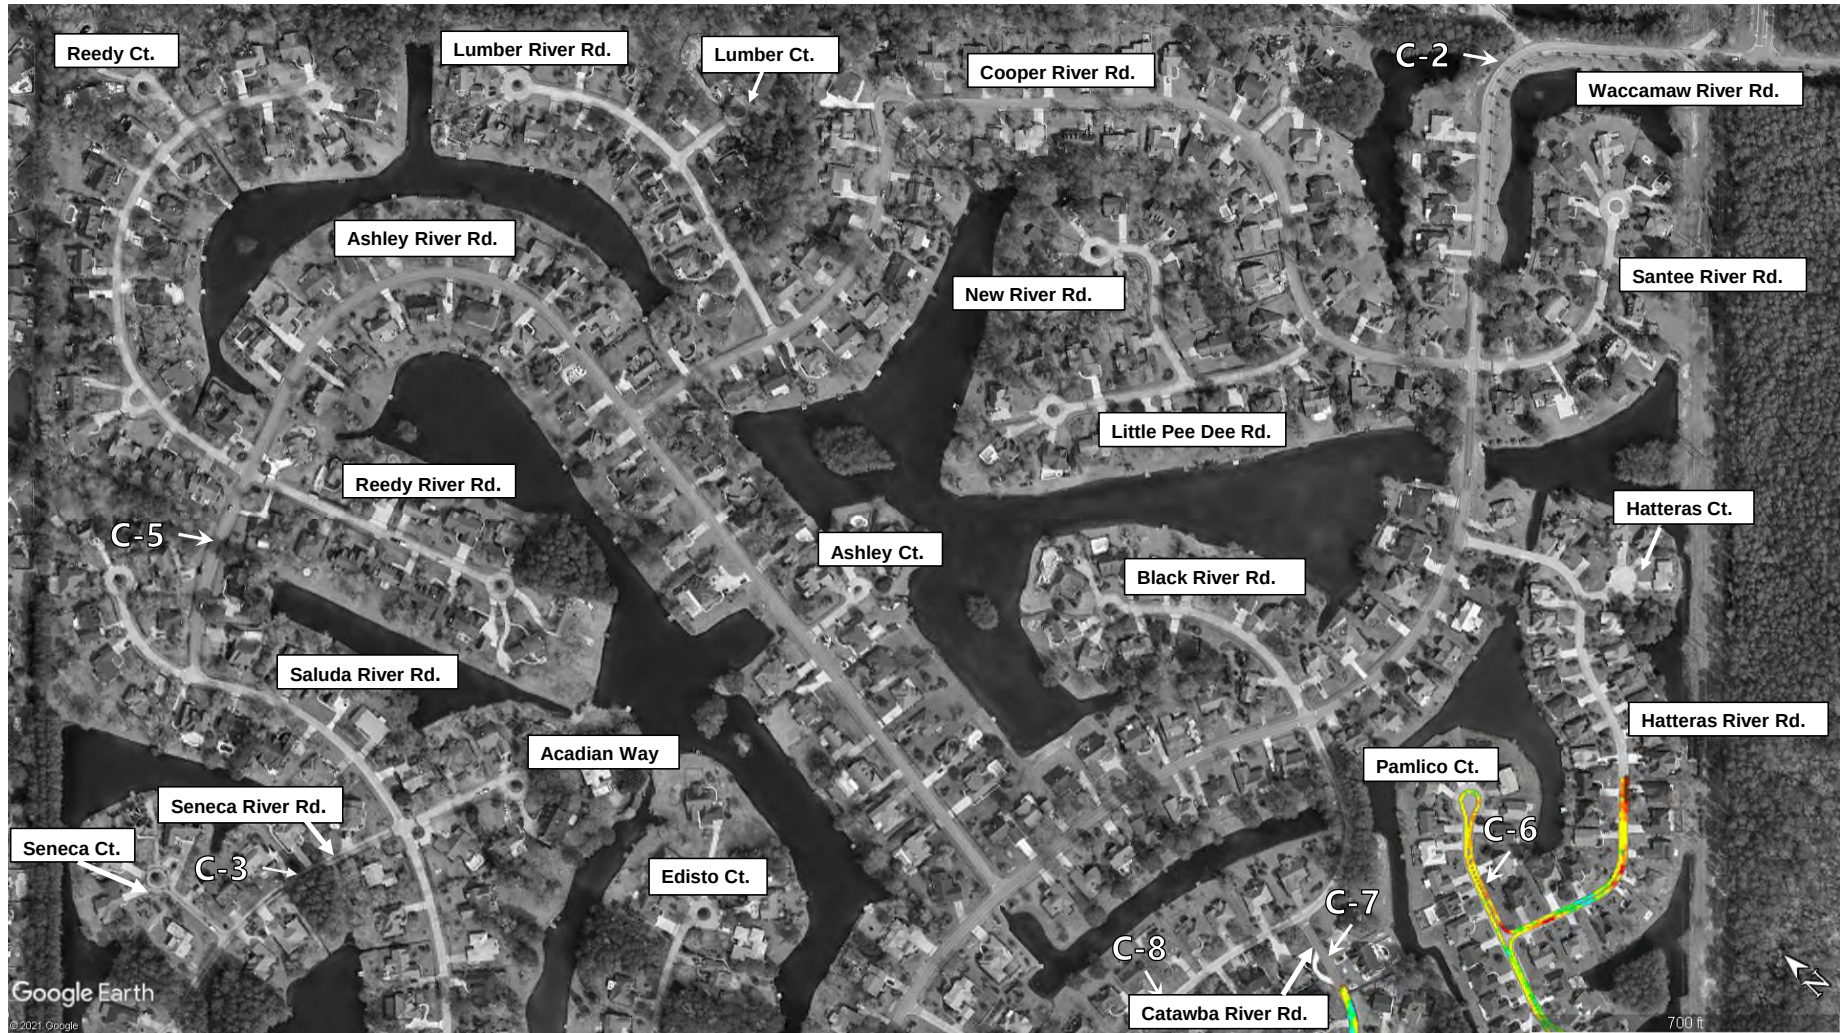
MARINE LIMESTONE THICKNESS PLOT - AREA A

- C. Areas colored in **orange** and **red** on **Figures 6 and 9** indicate areas where the MLBC layer appears to be less than 6 inches thick, which occurred in only a few isolated areas. Areas colored in **yellow** on **Figures 6 and 9** indicate areas where the MLBC layer appears to be less than 7 inches thick, which occurred in several areas of the evaluated area.
