April 9, 2021

The Lakes Homeowners Association  
529 Saluda River Road  
Myrtle Beach, South Carolina 29588

Reference: **Report of Pavement Exploration Services**  
**Pavement Inventory and Rehabilitation Plan – The Lakes**  
Surfside Beach, South Carolina  
S&ME Project No. 3563-20-064

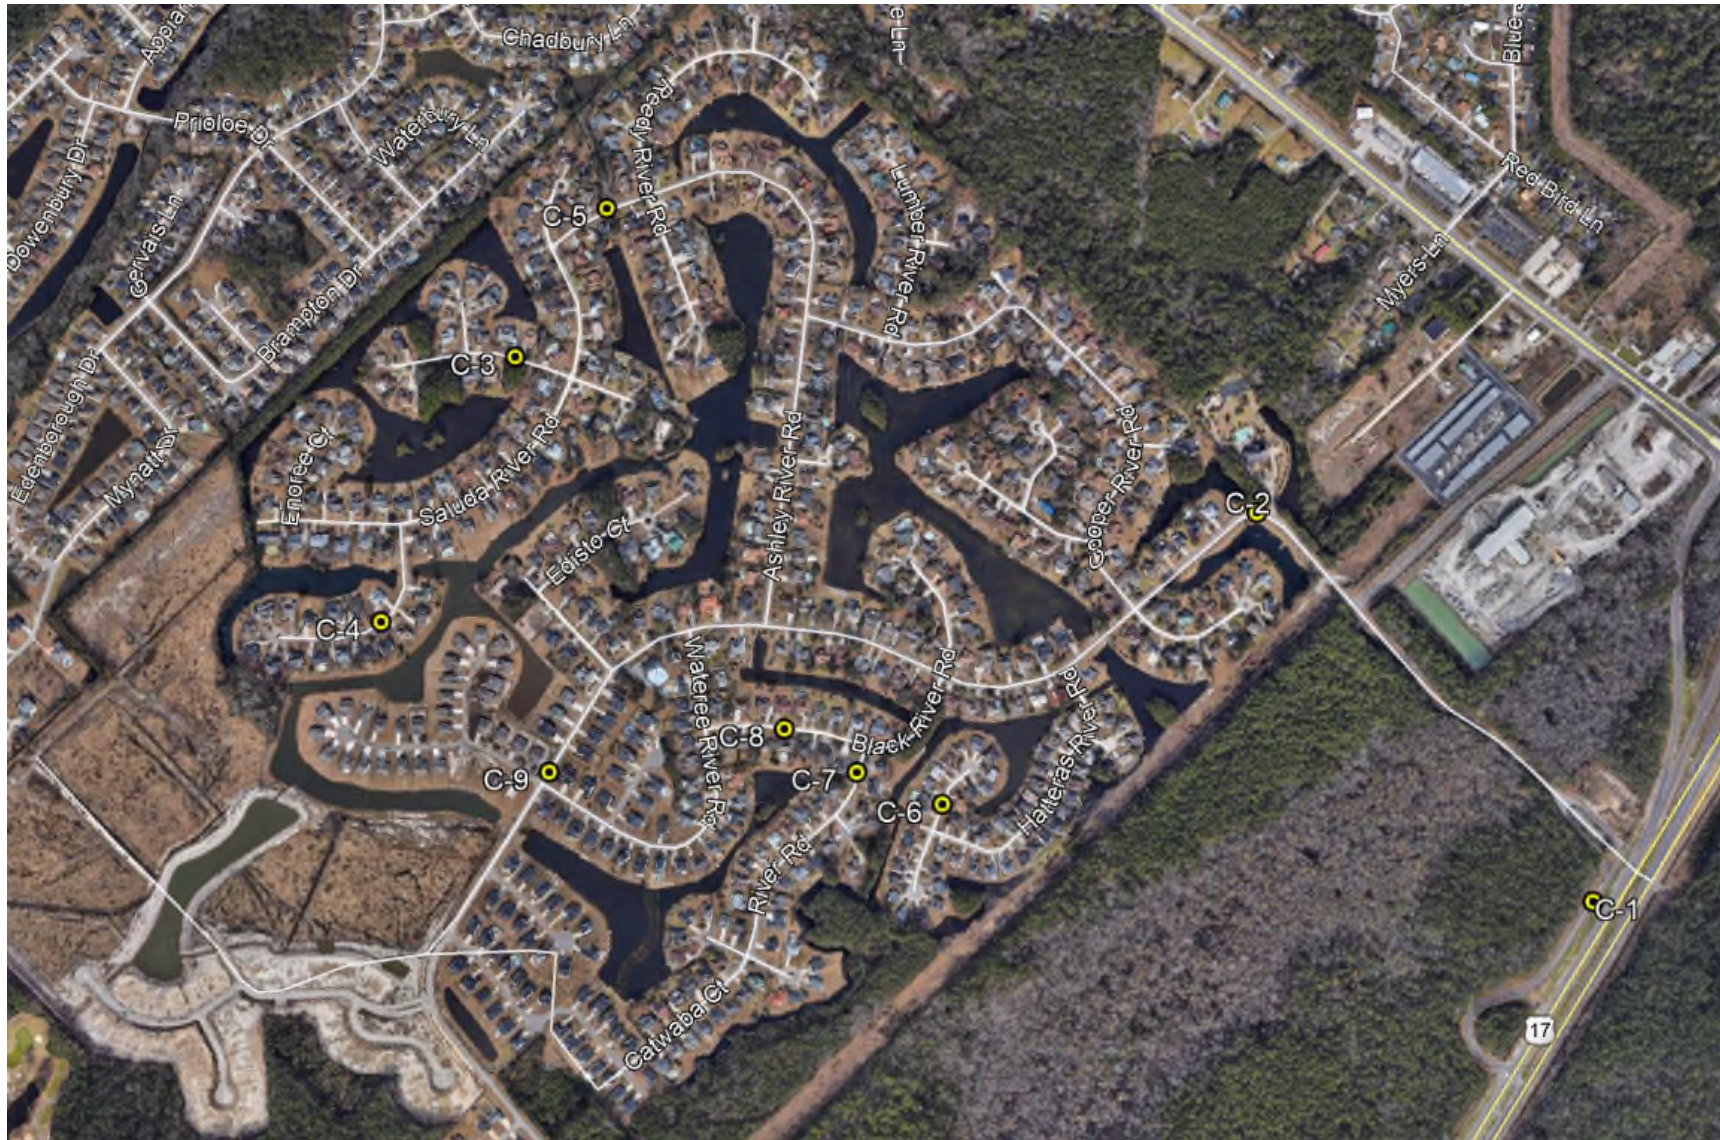
**CORING TEST LOCATIONS**

To perform the pavement inventory, we made use of Ground Penetrating Radar (GPR), in conjunction with a limited core sampling program. The Coring Test Locations are shown on **Figure 2** attached.
